Investigation of Cracked Lithium Hydride Reactor Vessels

E. L. Bird and T. M. Mustaleski, Jr.

Issue Date: July 2, 1999

Materials Engineering Department
Development Division

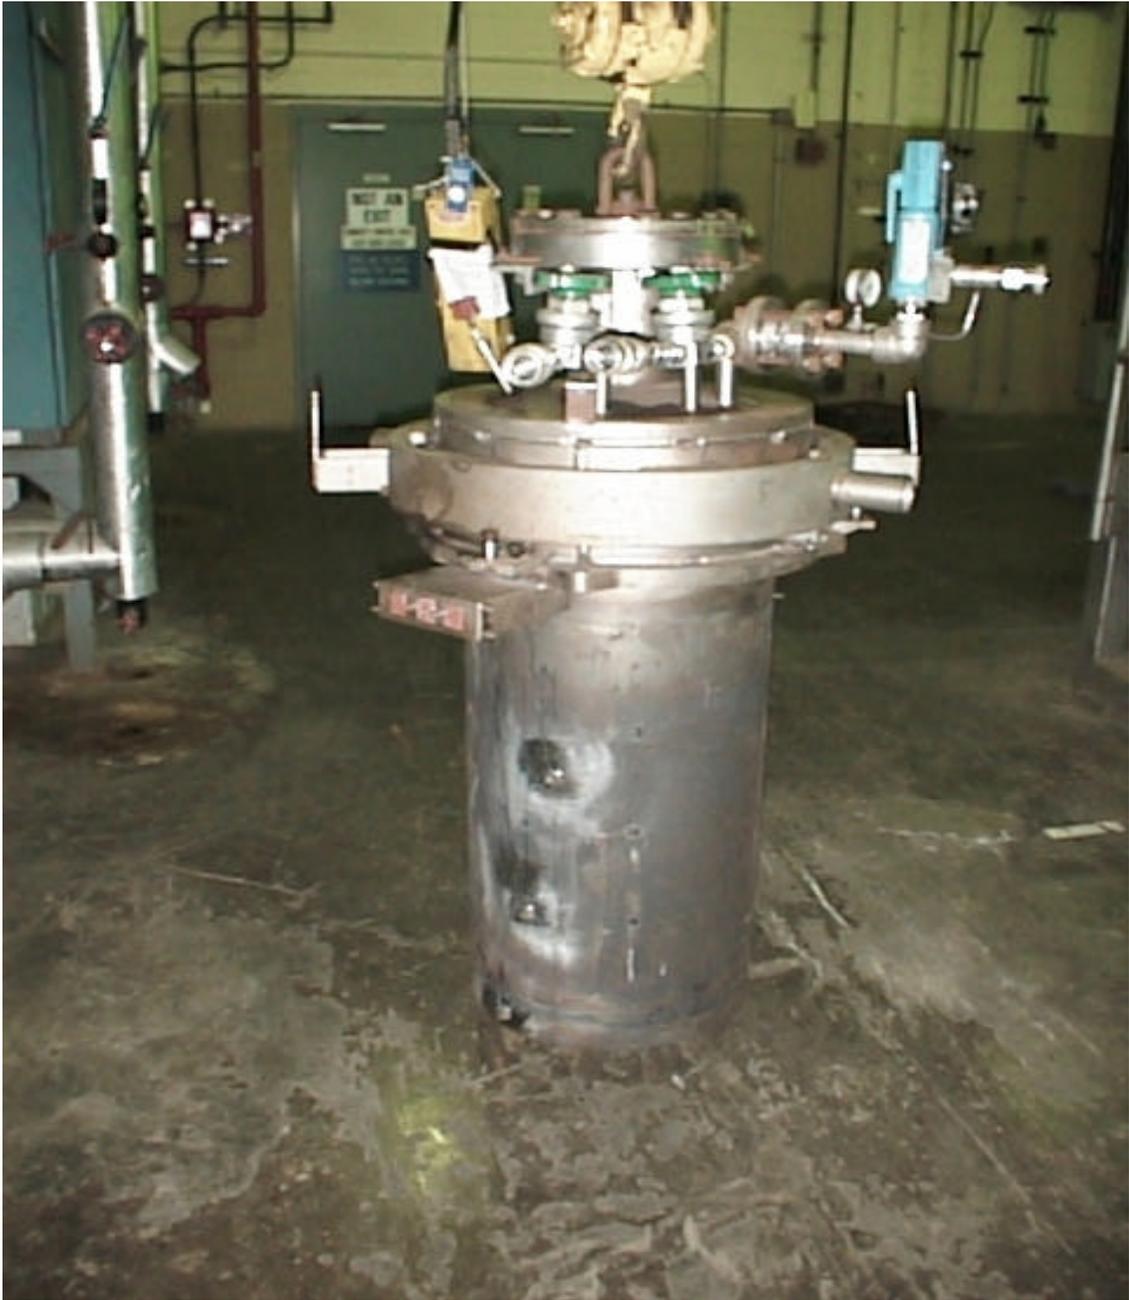
The vessels in question were in operation for some time; recently, however, numerous cracks were found during a visual inspection. Figure 1 shows one of the cracked vessels. Table 1 provides a history summary of the operating life of these vessels and inspection results. A typical operating cycle consists of ramping up slowly to ~700°C (1300°F), holding for several hours, and cooling by forced air. Most of the cracks were located along the circumferential welds at the bottom of the vessels. A few sections containing cracks next to the circumferential welds, similar to those shown in Fig. 2, were cut from two of the vessel walls and given to Development Division personnel at the Oak Ridge Y-12 Plant to perform failure analysis.

Fig. 1. One of the cracked LiH reactor vessels.

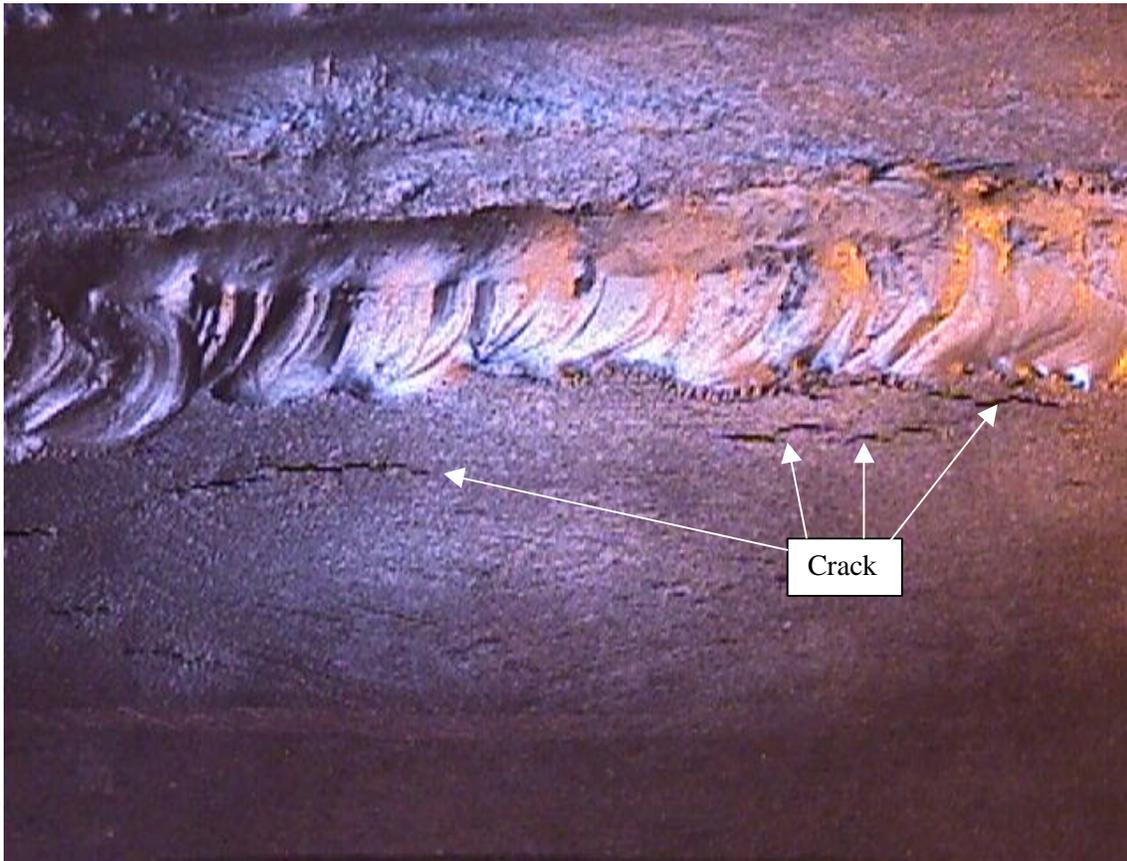
Fig. 2. Cracks found near weld at bottom of vessel.

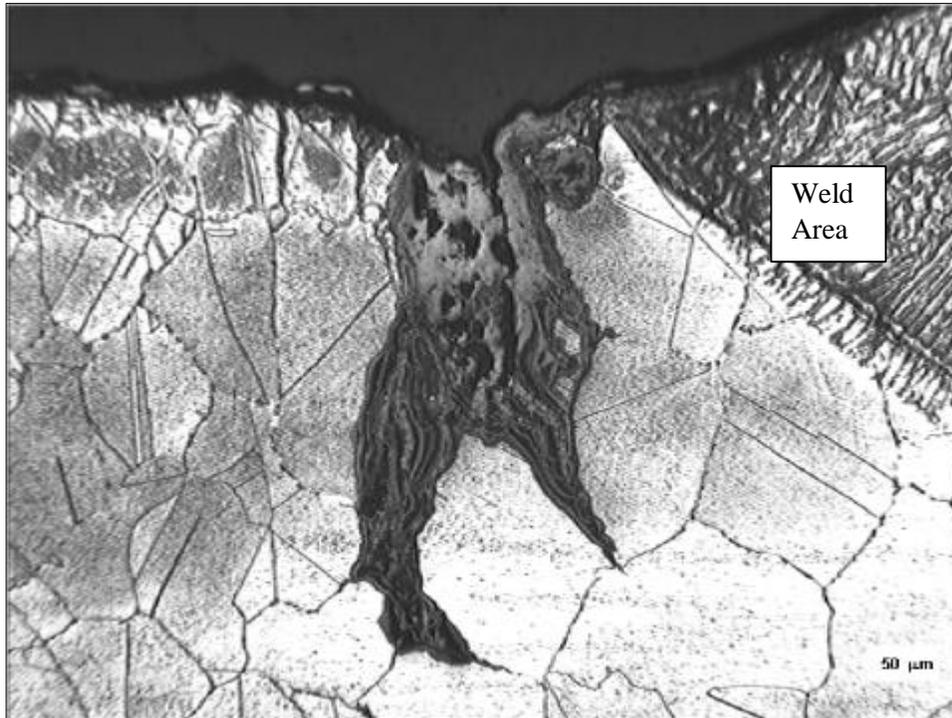
Figure 3 shows the crack in Vessel No. 6. The crack depth shown in Fig. 3 is ~300 μm and appears to be propagating intergranularly along the grain boundaries. The microstructure appears to be slightly sensitized, and Fig. 4 shows some evidence of large precipitates in the grain boundaries. Several specimens from Vessel No. 7 were prepared in the same manner for metallographic examination. Fig. 5 shows one of the cracked regions. The largest of these cracks is ~500 μm, and some evidence of sensitization exists, noted by the string of grain boundary precipitates as shown in Fig. 6. A crack ~1/8 in. long was discovered in the base plate. Sections were also taken from the weld and base material to verify the filler metal and base metal. That analysis appears in Table 2, which shows a partially diluted material that indicates that the filler metal is a nickel-based alloy similar to Inconel 617 and a substrate material that is similar to Type 309S stainless steel. During the course of the investigation, a short-term plan was developed to use portions of the “older” vessels manufactured by the Nooter Corporation of a different design, so that operations would not have to be shut down for the procurement of new vessels. Chemical analyses of those vessels, which were obtained before acceptance for repair, are also reported in Table 2.

Fig. 3. Cross section of cracked region of Vessel No. 6. Weld area in top right corner.

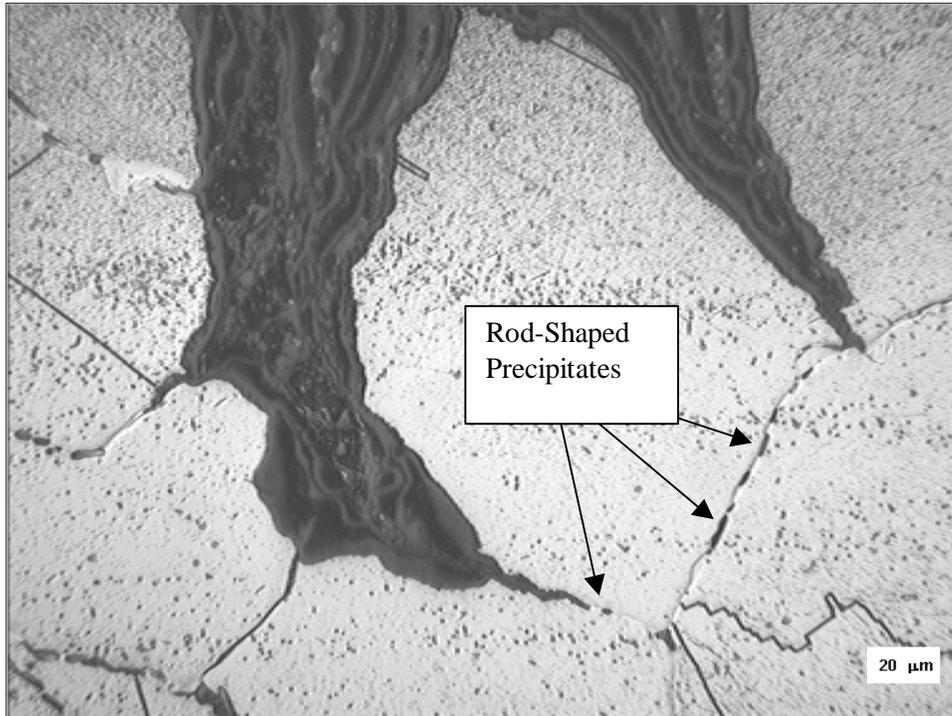
Fig. 4. Tip of crack shown in Fig. 3. Note crack propagation along grain boundary and what appear to be rod-shaped precipitates along grain boundary.

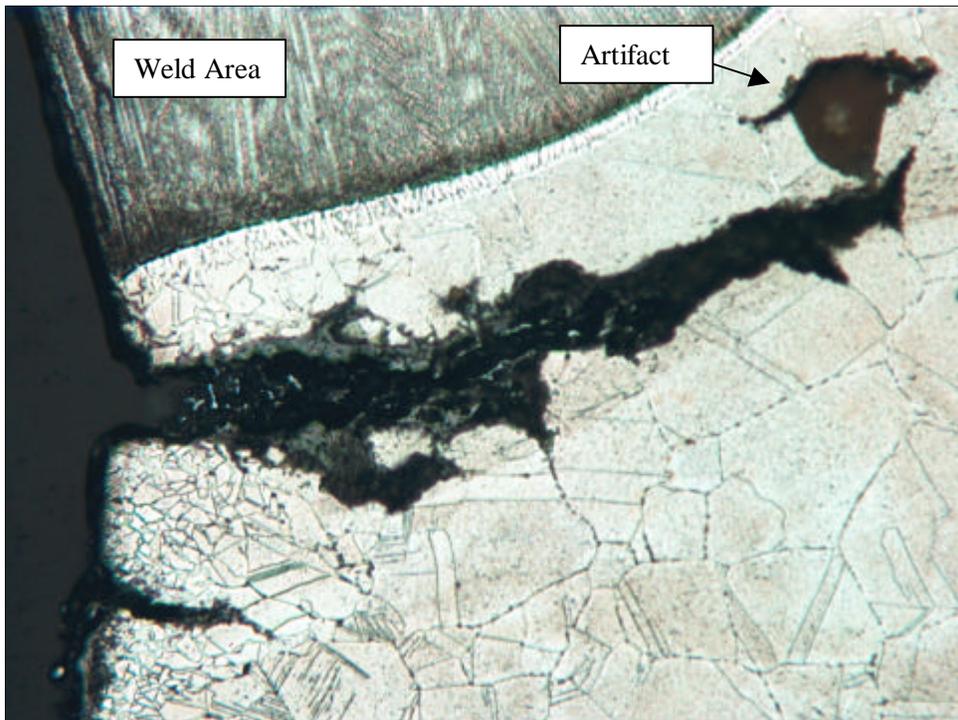
Fig. 5. Cracked region of Vessel No. 7. Weld region located along top left portion.

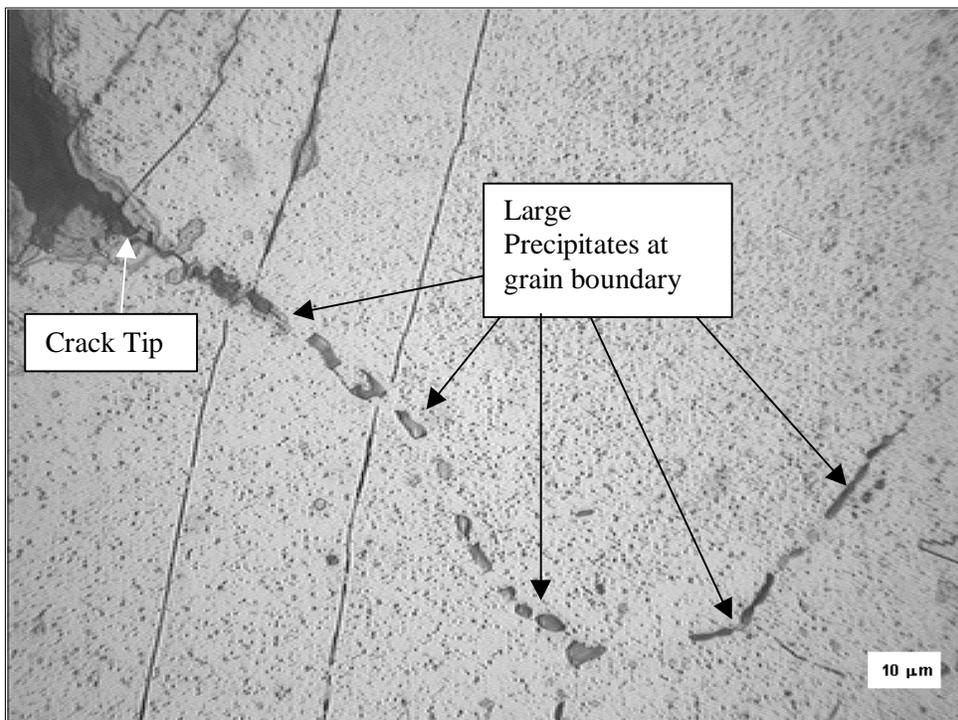
Fig. 6. Tip of crack shown in Fig. 5. Note formation of large precipitates along grain boundary and direction of crack propagation.

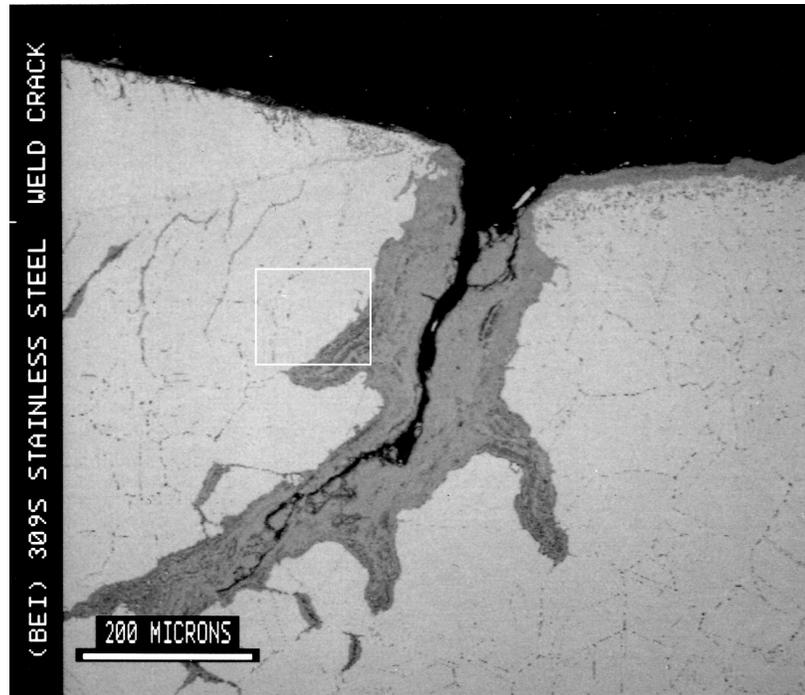
After metallographic evaluation was completed, two of the same specimens from Vessel No. 7 were taken to the Plant Laboratory for SEM evaluation. Backscattered electron images (BEIs) of the material within the crack, shown in Fig. 7, indicate the presence of at least three different phases. EDX analysis of the material surrounding the crack was performed to identify the heavier, metallic elements, keeping in mind that elements in the periodic table below sodium are not detected by this technique. Figure 8 shows the results of the EDX analysis of the material within the crack. A white or bright field indicates the presence of the element. Nickel is shown in the top right, iron is shown in the bottom left, and chromium is shown in the bottom right. Seen in the microstructure in Fig. 9, the grain boundary precipitates near the crack shown were determined by EDX to be chromium rich.

Fig. 7. BEI of material (dark gray) surrounding crack; enclosed region of crack material was analyzed to determine chemistry.

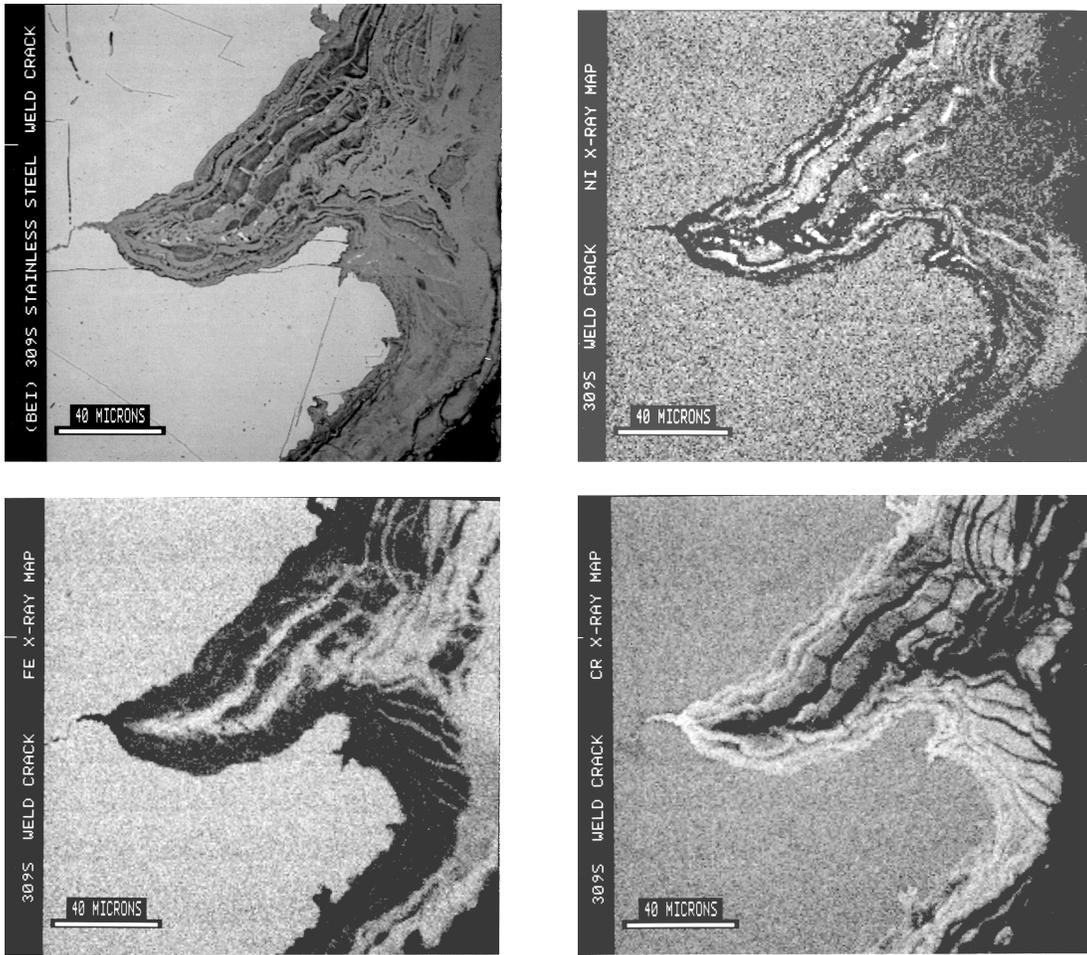
Fig. 8. EDX analysis of material in crack: Ni, Fe, and Cr.

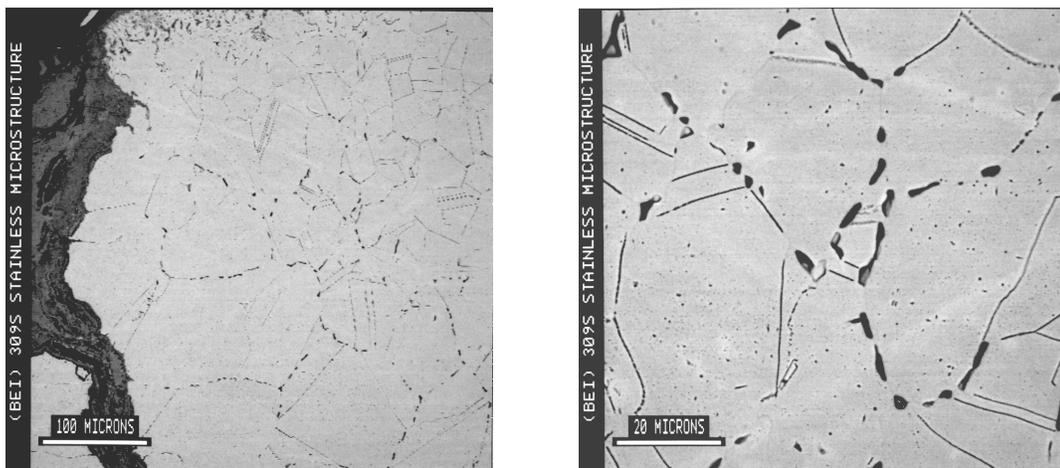
Fig. 9. Section near the crack showing precipitates rich in chromium-carbon in the Type 309S stainless steel base metal.

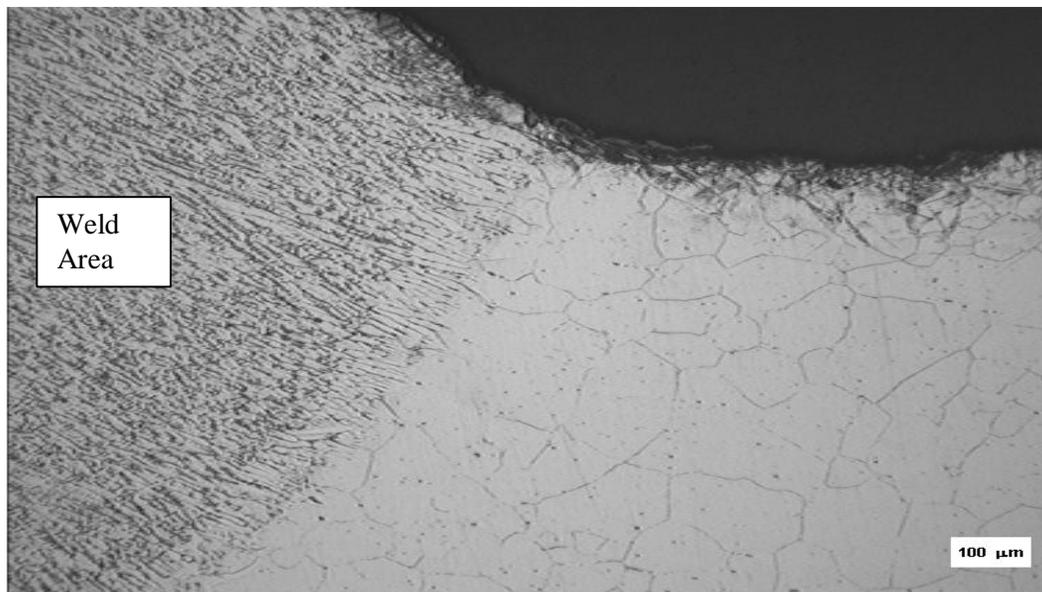
Another section of a curved-bottom vessel (No. 1134-170) was examined for cracks and microstructure, and a chemical analysis was performed to verify the filler metal. There were no cracks; the microstructure, shown in Fig. 10, looked normal; and both the filler metal and base metal were identified as Type 309S stainless steel. In fact, the microstructure showed very little evidence of sensitization. This was rather surprising too because most material handbooks indicate that austenitic

Fig. 10. Welded region of Vessel No. 170 is crack-free and shows very little evidence of sensitization.
